TECHNICAL REPORT

NO. 12609

Acoustic Emission Monitoring of Production Armor Plate Welds

Final Report

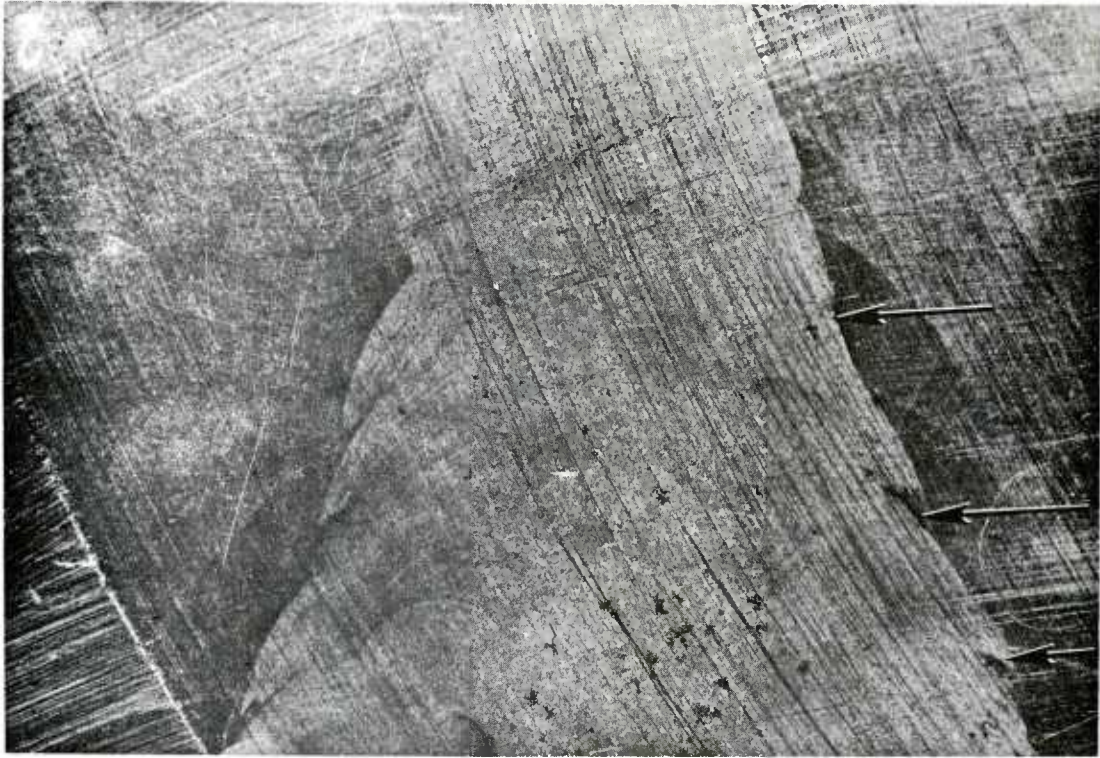
Figure 1 Lack of Fusion (Section 2)

Section 2 (Figure 1) was cut from a radiographically clear but acoustically active area 33 to 35-in. from the weld start of plate 5. Figure 1 shows several small regions of unfused metal along the lower right wall, agreeing with the observed acoustic persistence of this source in side 2 passes 7 and 11 (Figure 2). Section 1 (Figure 3) was cut from a radiographically clean but acoustically active area 4 to 6 inches from the weld start of plate 5. Figure 3 shows the presence of one unfused region on the upper left bead boundary. This agrees with the acoustic record (Figure 4) in that an indication from this location occurred during the welding of pass 4 of side 1. As a reference, Section 3 (Figure 5) was cut from an acoustically inactive radiographically clear area 10 to 12-in. from the weld start of plate 5. Figure 5 shows nothing but one spherical pore near the weld root. This flaw type is usually acoustically inactive; hence it is not surprising that it went undetected.

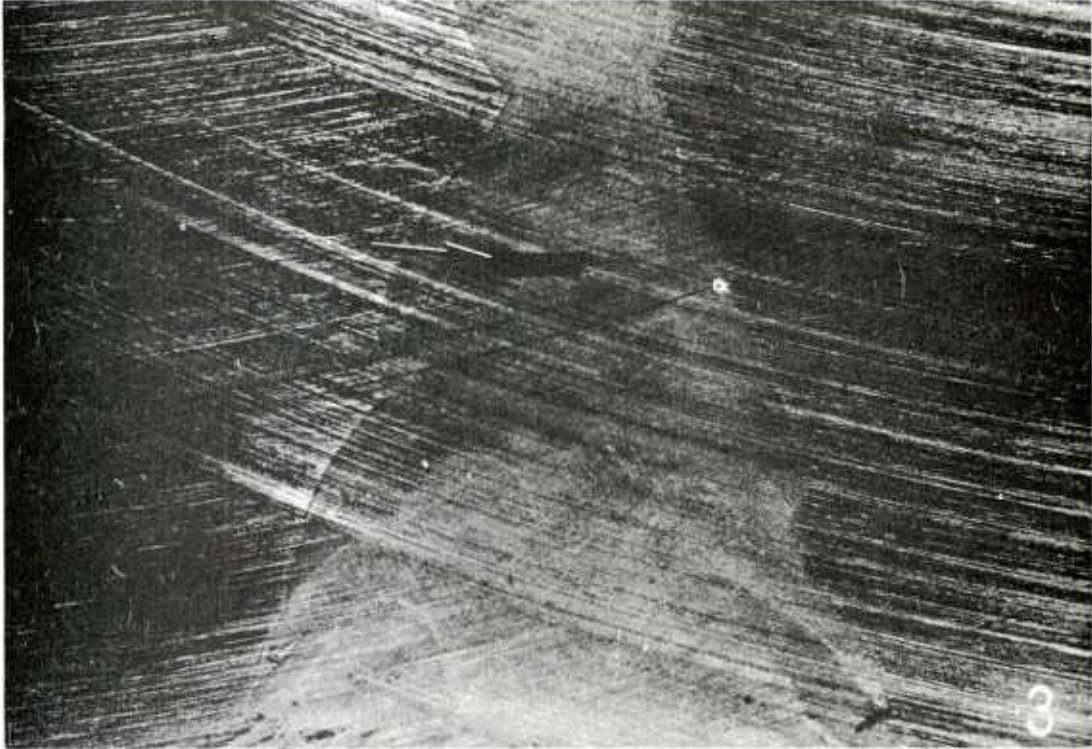
Figure 5 "Flawless"(Section 3)

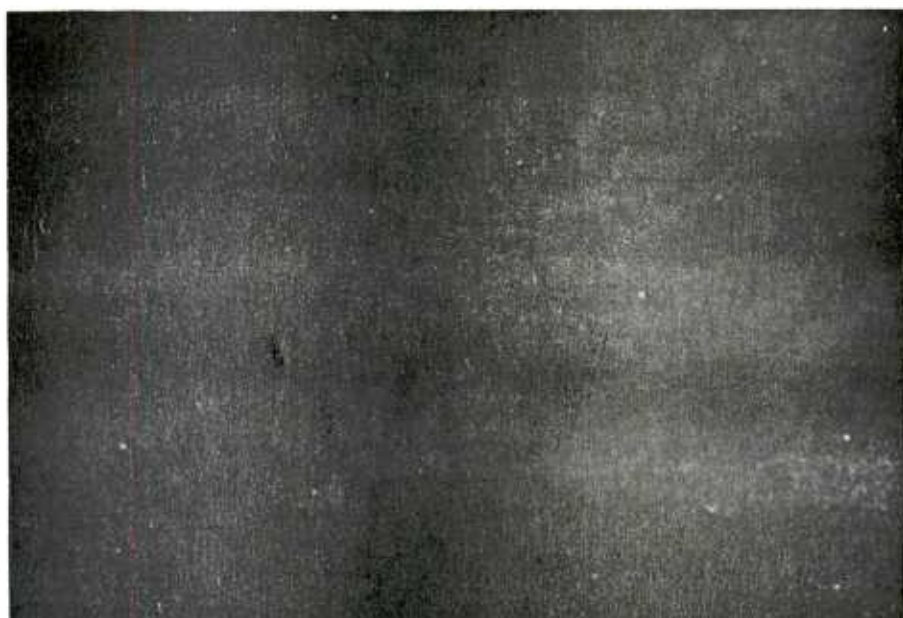
(a) Macrograph

(b) Radiograph

Figure 6 Section 7

To extend our examination of the true nature of acoustic sources, two more sections, in which acoustic activity was detected but no flaws were intended, were cut from areas in Weld 11: one had radiographic correlation, one did not. Section 4 was cut from the first 4-in. of Weld 11, a region of extremely dense acoustic activity and radiographic indication of a porosity string. Figure 9 is an example of one of the many sections sliced through this region; lack of fusion and incomplete penetration with associated voids appear to be the predominant flaw types. Section 5 was cut from an active acoustic area in which no radiographic indication was observed. However, as Figure 10 shows, incomplete penetration was the apparent acoustic source.

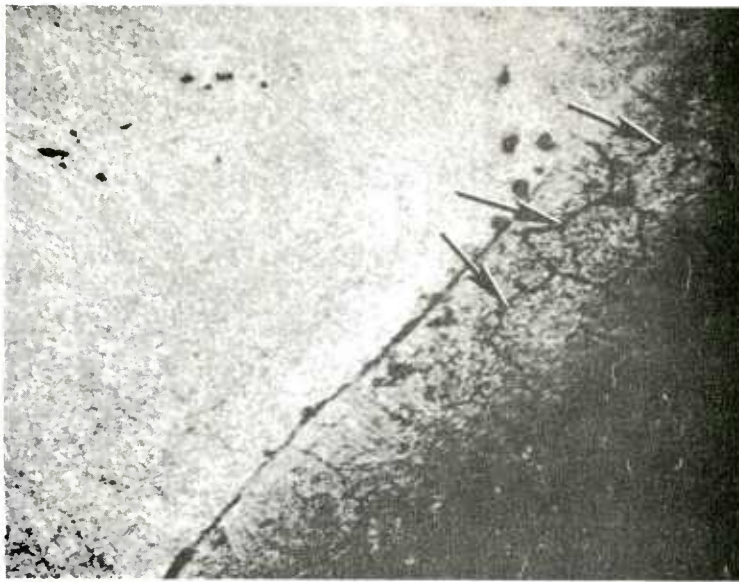
150 X Magnification

600 X Magnification

Figure 7 Metallographs (Section 7)

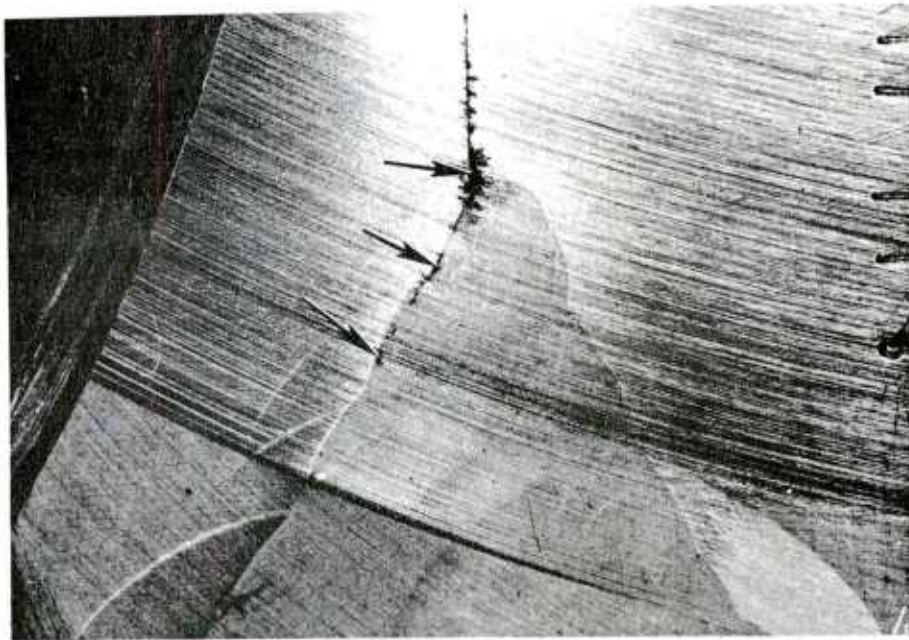
Figure 9 Lack of Fusion, Incomplete Penetration
(Section 4)

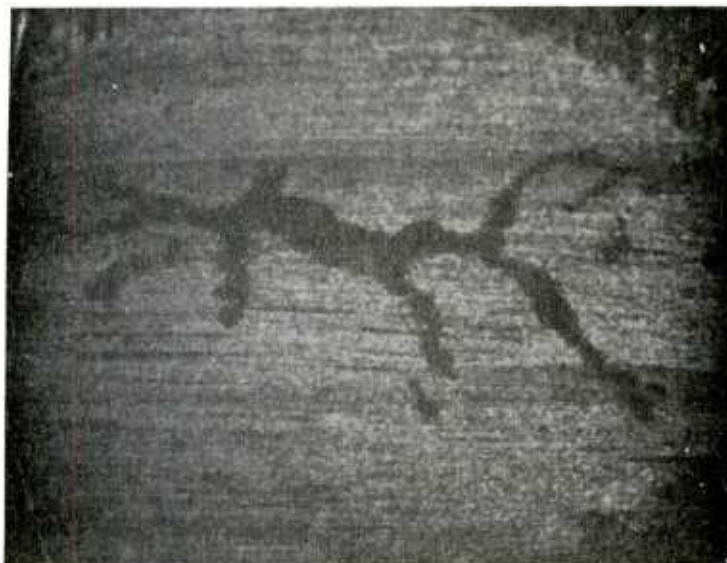
Figure 15 Crack in Weld 28

Eleven production welds were monitored. Two of the welds had dye penetrant verified flaws which were detected by acoustic emission. In Weld 28, a series of reactivating indications commenced during pass 3 and persisted thru pass 6. Nothing could be seen in this area with the un-aided eye, but when dye penetrant was applied, the flaw indication shown in Figure 15 appeared. It was repaired before radiography. In weld 32 during welding of pass 7, a crack indication occurred about 28 inches from the end of the weld, a few seconds after the welder stopped his arc and went to get a hand grinder. He had accidentally allowed the weld torch gas cup to contact the weld, creating a rough surface that he intended to smooth before continuing. The mention of the AE crack indication prompted the welder to have an inspector perform a dye penetrant test after grinding. Figure 16 shows the resultant crack network. The welder continued grinding until dye penetrant inspection showed no more evidence of a crack. The welding resumed with no further acoustic indications observed.

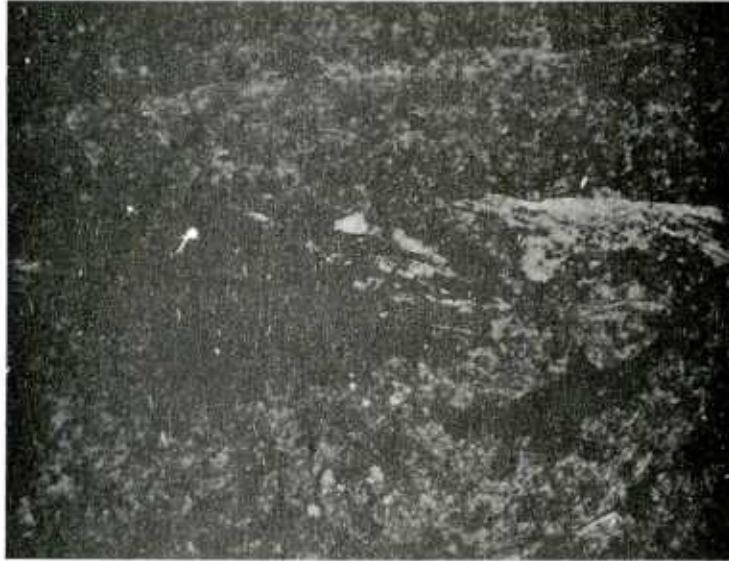
Figure 16 Crack in Weld 32
